Kansai International Airport (HKN047)

Soil:	Landfilled gravel, sand, mudstone
Method:	Deep dynamic compaction, SCP
Foundation:	Direct base (shallow)
PGA:	0.25g H
Damage:	Minor cracks

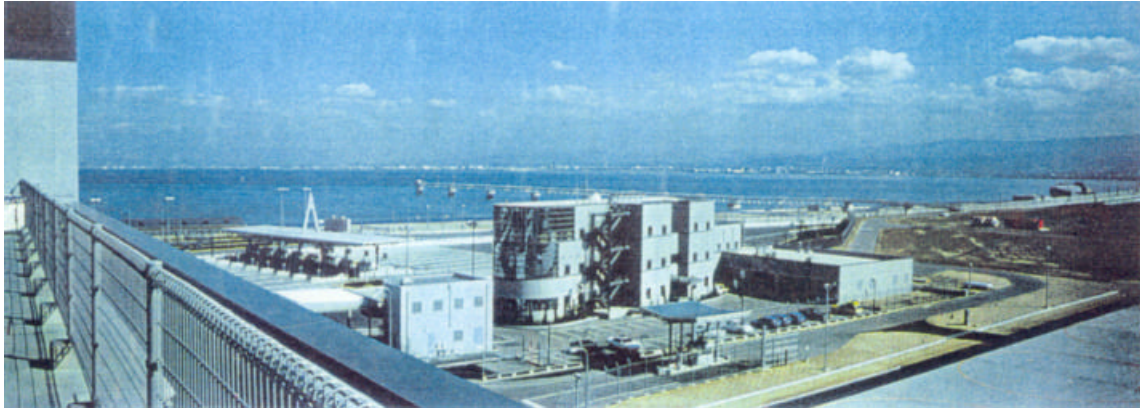
Figure 3. Toll plaza at Kansai International Airport (Kaiyo Kogyo, 1995)

Little damage was reported as a result of the 1995 Hyogoken-Nanbu earthquake. No damage was reported to buildings. In the runways, 10 or more cracks less than 3 mm wide were reported. The cracks, however, were inconsequential. Figure 3 shows the toll plaza and other facilities after the earthquake.

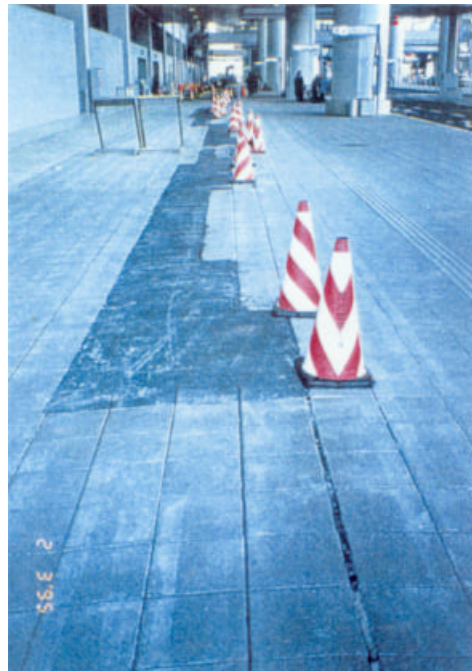
Settlement and other damage was observed in walkways that were unimproved, as shown in Figure 4.

Figure 4. Cracked area of walkway (Kaiyo Kogyo, 1995)
